ULSD Corrosion: Finally, an Answer?

By: Richard L. Chapman, Innospec Fuel Specialties

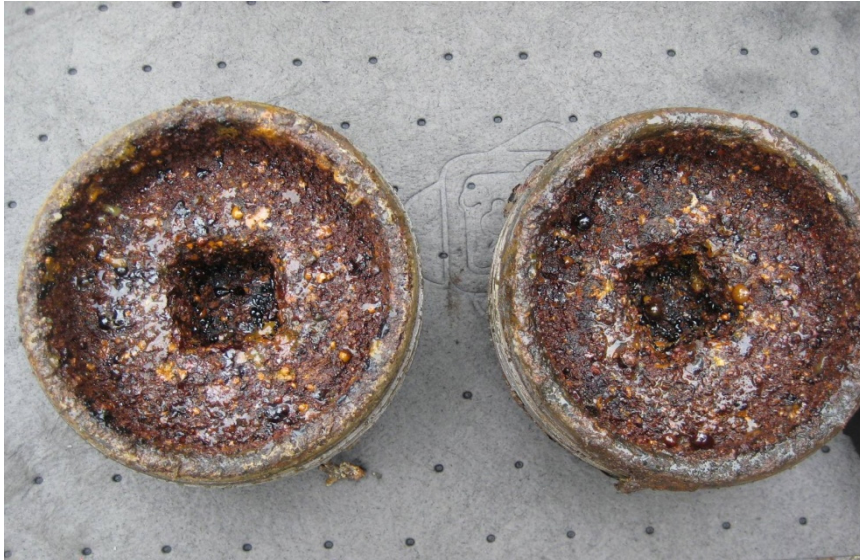
Figure 1. UST Steel Caps (Inside View) from a newer fiberglass ULSD tank (highest point in the vapor space, with little or no fuel contact).

With all of these changes, the propensity for bug growth in ULSD fuel systems has increased dramatically. The bugs can be either aerobic (needing oxygen) or anaerobic (needing no oxygen) and can be found in both the fuel and water phases. In some cases, bugs have been found even in corrosion "barnacles" in the overhead space.

Typically, the anaerobes generate the damaging acids. These weak acids have higher vapor pressure than the diesel fuel and thus rise to the top of the storage tanks, lines and dispensing equipment. This appears to be one reason why so much "above the fuel level" corrosion has been reported in ULSD systems.
